Sheldon Vermont Spring Trip. Nov 7, 2017

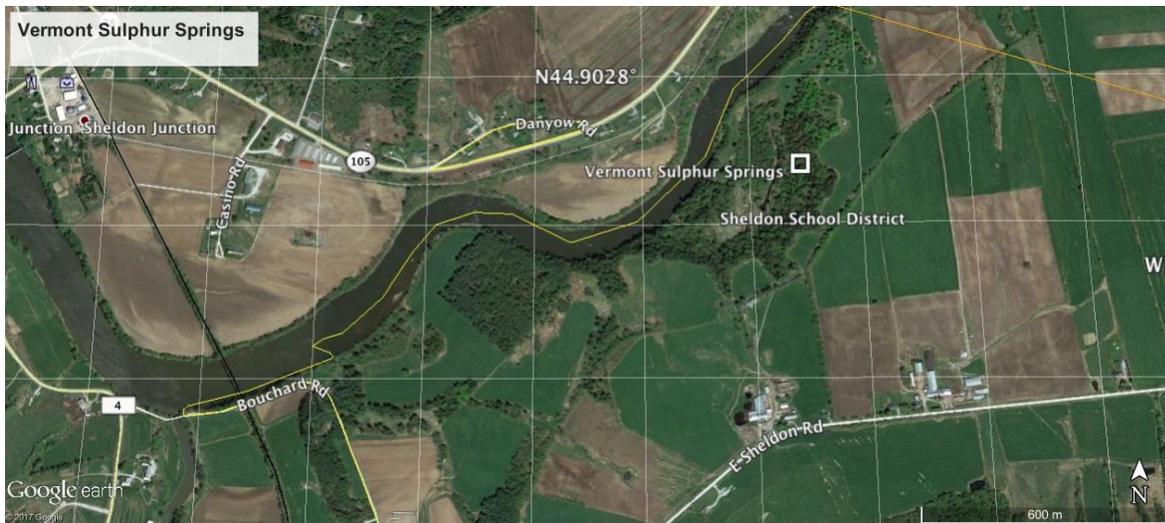
Figure 1. Vicinity of Vermont Sulphur Springs. The springs are located on the south bank of the Missisquoi River. They are south of Sheldon Junction and are the closest springs to Sheldon Junction.

The first spring was the Vermont Sulphur Springs (Figure 1), located on E. Sheldon Road on the farm of Daniel and Susan Lussier. The historically recorded temperature of this spring was 45°F. The historical flow rate was 7 gallons per minute. The spring is located at 44.90060°N -72.92352°W and an elevation of 411 ft. The spring forms a small pond with a maximum temperature of 7.6°C (45.7°F), in excellent agreement with the historical temperature. Because there was no restricted outflow zone from the pond, we were unable to estimate the present day flow rate.

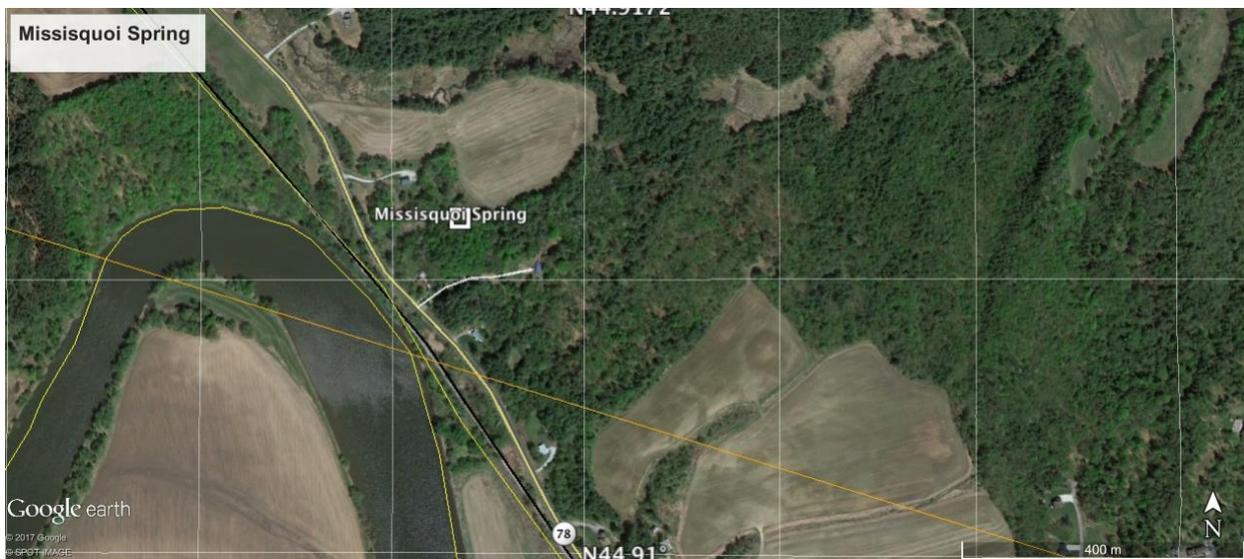
Figure 2. Google Earth image of vicinity of Missisquoi Spring (white open square). The spring is located close to the north bank of the Missisquoi River. Sheldon Junction is south of Missisquoi Spring.

The Missisquoi spring was located in a stream crossing on RT 78 next to the hill where the hotel had been located. This land is now part of a working farm. The location of the Missisquoi Spring is characterized as Sheldon Junction on an old bottle owned by Gerald Dexter. The spring had a nice springhouse that is shown in old pictures. The historical flow rate of the spring was 2 gallons per minute and the substrate was glacial clay. The spring at Sheldon Junction was described as forming a slimy mineral deposit.

We found a possible spring beneath the roots of a tree in the stream valley. The water temperature was 7.5°C (45.5°F). Because the spring was so close to the level of the stream, we were not able to estimate its flow rate. The possible spring is located at 262 ft., 44.9144°N, 72.95633°W. The stream valley is filled with silt and bushes and it is difficult to be completely sure that we located the original spring site. Soil erosion and fertilizer runoff may be contributing to the dense vegetation and silt that is rapidly filling the stream valley. The original springhouse and its foundation may be buried beneath this more recent material.

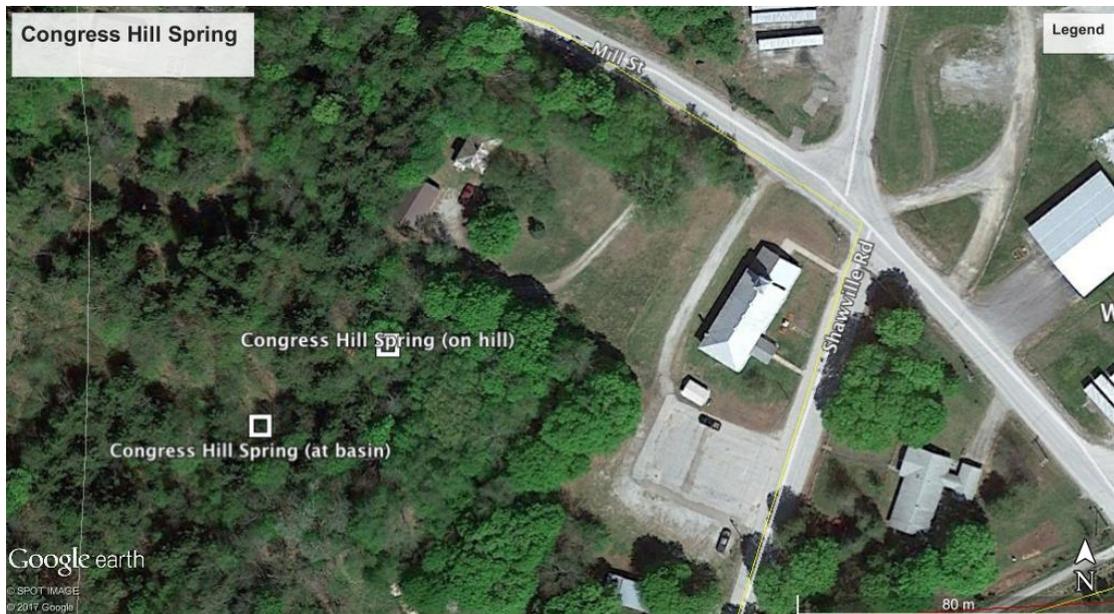
Figure 3. Congress Hill Spring (white open square) on Google Earth. We also sampled a stream on the hill. The large building at center right is St. Anthony's Rectory at 117 Shawville Road.

The third spring we visited was the Congress Hill spring (Figure 3) on Shawville Road. The spring is located in a steep valley behind the parking lot of a church. We made two measurements of water temperature, one on the hillside and one at the bottom of the valley. There is a concrete basin in the valley that houses the spring. The temperature of the water in the basin was 9.7°C (49.46°F), somewhat higher than that of the first two springs. The surface of the water appeared to contain a floating coating, which might represent the growth of mineral loving bacteria. We have seen similar floating material at other springs where we know that the water is clean and potable. This floating coating may be the slimy mineral deposit described by historical sources as occurring on top of the spring water in Sheldon Junction (Missisquoi Spring). Because there was no outlet to the enclosed basin, we could not estimate the flow rate of the spring. The Congress Hill Spring is located at 326 ft., 44.90525°N, 72.97858°W.

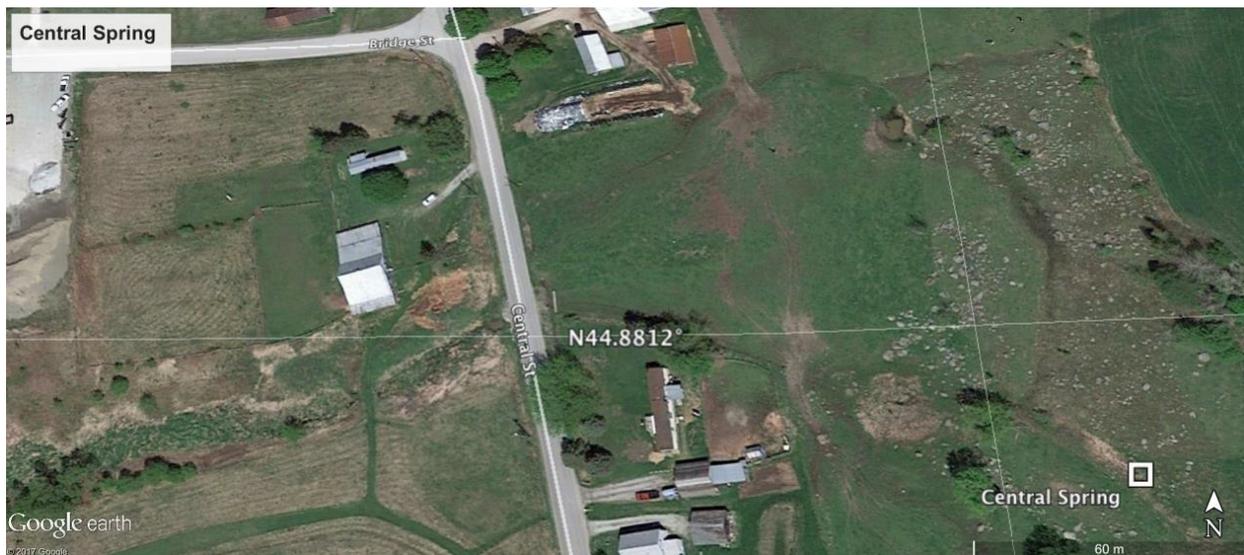
Figure 4. Vicinity of Central Spring (white open square), Sheldon Vermont. The poorly vegetated areas near and below the spring are areas of intense water seepage.

The fourth spring we visited was the Central Spring (Figure 4) at 276 Central St. in Sheldon, Vermont. The spring is on a working farm. This spring had many diffuse outlets. There was a large area that was flooded from 6 inches to a foot in depth with tufts of grass sticking up through the water. We found a concrete basin near the base of the flooded area, where we measured a temperature of 8.0°C (46.4°F). Because the basin had no spigot, we could not assess the flow rate. However, the large lateral extent of the flooded

area uphill of the basin implied that water was seeping out of the ground at numerous locations. We found many sites uphill of the basin that contained warm water seeping out of the ground. At the site with the most rapid flow, the water temperature was 10.3°C. (50.5°F). At the higher temperature site, we filled about 1/5th of a 21-liter bucket in 4 seconds for a flow rate of 19.2 gallons per minute. This site was located at 440 ft., 44.9061°N, 72.97763°W.

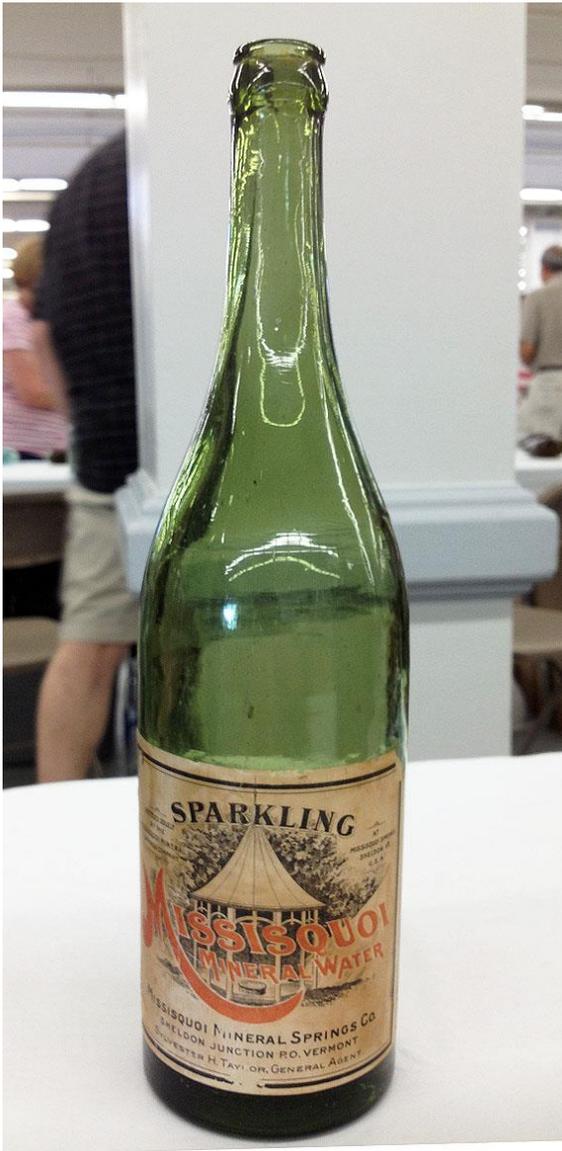
Figure 5. Water bottle from Missisquoi Spring collected by Gerald Dexter.
